Reference - STI AF-SBC-95-002

Retro-Fit replacement of existing Low Fuel Warning Float Switch Type with Optical Liquid Level Sensor System.

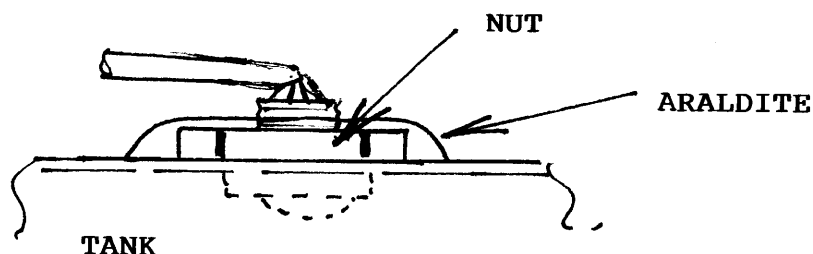
Apply Araldite Epoxy Resin Glue (either 5 minute or normal pack) around the nut and thread area ensuring that complete area of nut is covered and spread over tank by at least 2mm.

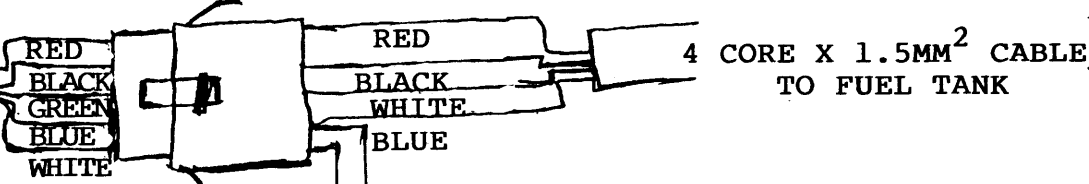
OLD PLUG HALF
(LEAVE HANGING)

WIRES MAY BE ENTERED INTO A BLANK PIN HOLE OF THE SIX AVAILABLE AS LONG AS POLARITY IS MAINTAINED

- 3.b. Electrical power connection for unit. Refer to attached wiring diagram and connect accordingly.
