Reference: STI AF-SBC-97-004

Special Technical Instruction - Possible cracking to engine mounting plate to limited number of later production aircraft.

AUSTFLIGHT ULA PTY LTD

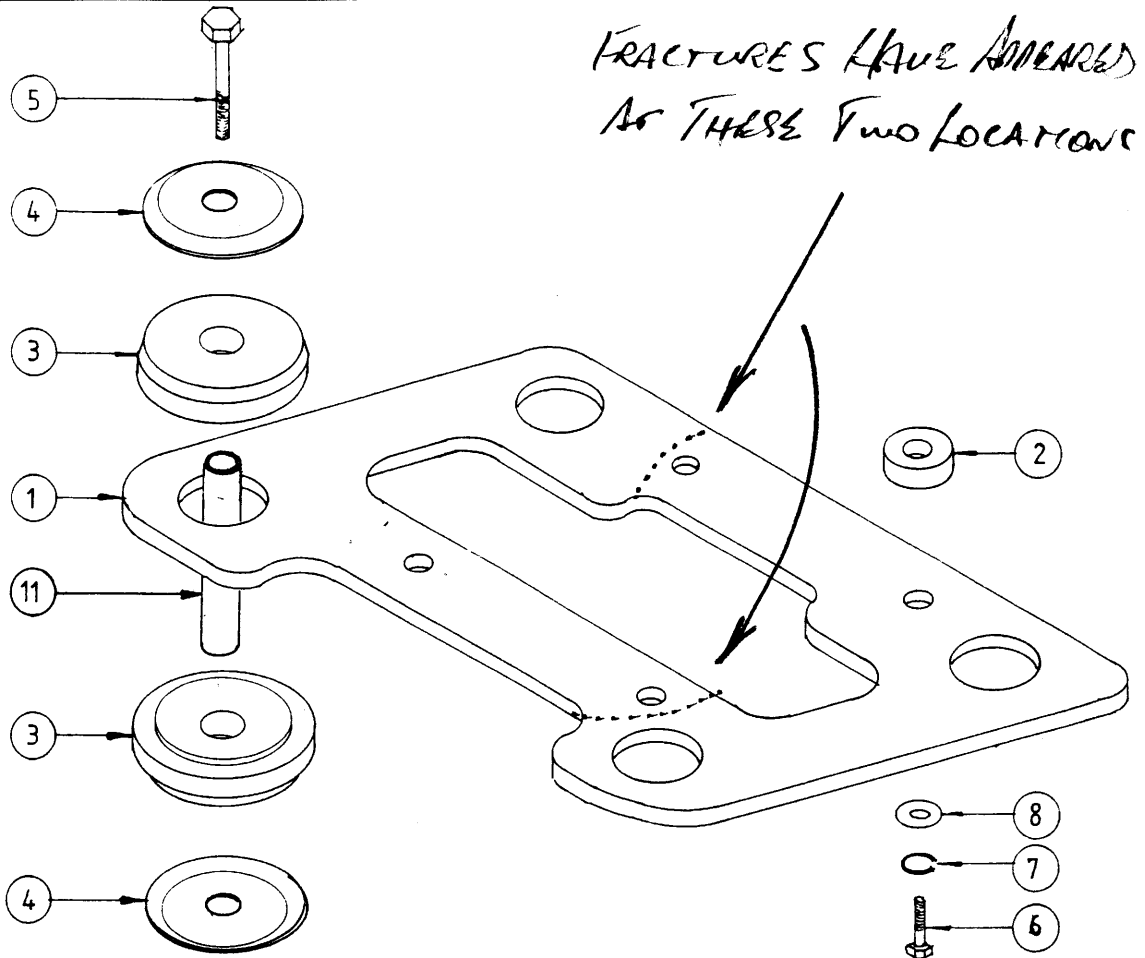
Problem: Two separate incidents have been reported to this factory of high hour training aircraft found to have fractures appear in the aluminium engine mounting plate. Our history file would indicate this problem is limited to later build aircraft using the red polyurethane mount rubbers.

Fracture initiates from contact point of metric 10 bolt washer and proceeds forward and aft on the centre section of the plate.

The plate is not difficult to change and requires only the exhaust mount rubber strip, four metric 10 engine to plate bolts and the four plate to frame bolts to be removed. The engine can then be lifted sufficiently to slide the old plate out and the new one in.

Ensure plate is installed with engine offset to the left of airframe centre when viewed from the rear, looking toward the propeller.

The four metric 10 bolts are secured with Loctite 222 and torqued to 40 nm (30 Lbf ft) then lockwired. The four 5/16" bolts and nuts securing the poly mount to the frame are torqued to 14 nm (10 lbf ft).

The four 3/16" bolts securing the exhaust rubber strip are lightly tensioned.
