Reference - STI AF-SBC-95-002

Retro-Fit replacement of existing Low Fuel Warning Float Switch Type with Optical Liquid Level Sensor System.

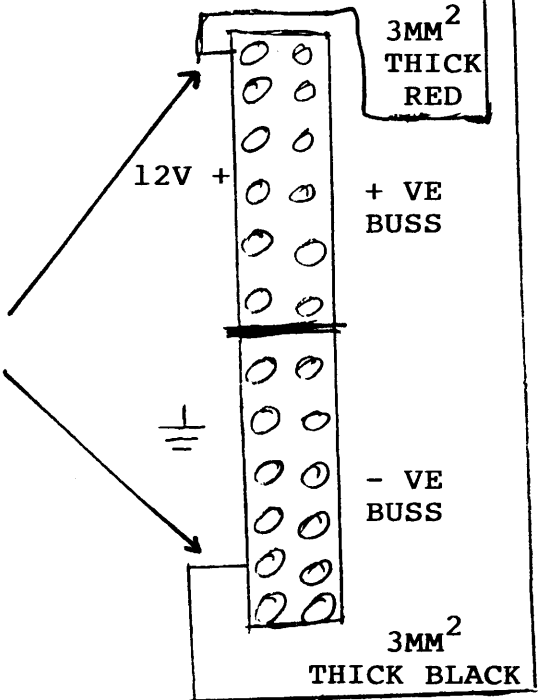
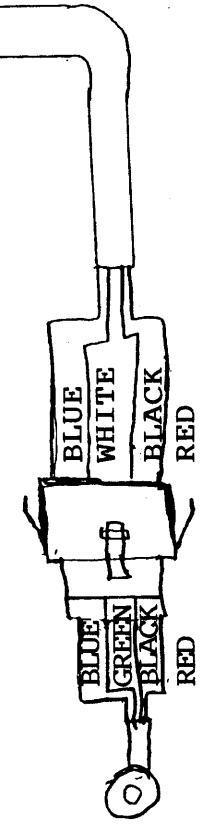
FUEL TANK
SENSOR

WIRES MAY BE ENTERED INTO A BLANK PIN HOLE OF THE SIX AVAILABLE AS LONG AS POLARITY IS MAINTAINED

6007-4
PLUG ASSY.
